Case Study

MEXICO
Carlos A. Parra,
Xpert Stone

Stone/Tile: Mexican Cantera and Saltillo

Product: STAIN-PROOF™ and ENHANCE PLUS™

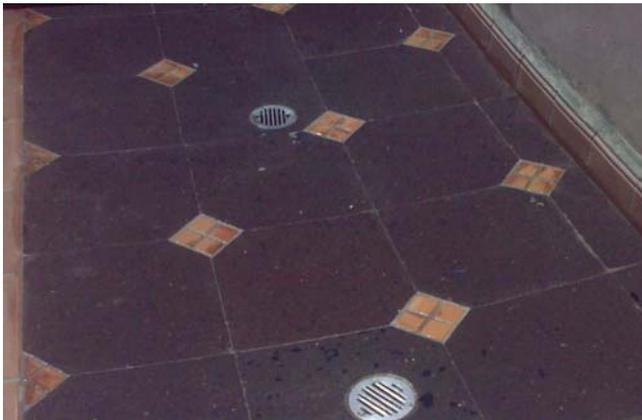
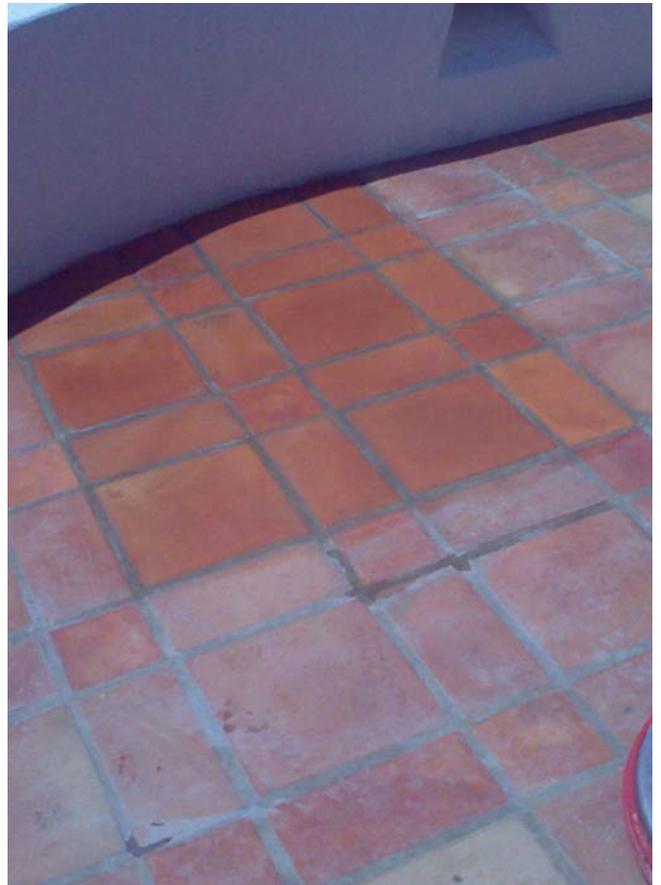
The project required the rejuvenation and sealing of the highly porous Mexican Cantera and Saltillo tiles at a beach front property in Mexico. The Mexican Cantera and Saltillo tiles were faded with signs of salt-efflorescence over the entire area. The salt-efflorescence was caused by water being able to move freely through the material. Water carries dissolved minerals which can be deposited on the surface when the water evaporates, leaving visible white patches.

Xpert Stone specialist sealing expertise removed the existing staining and salt-efflorescence, before applying two coats of ENHANCE-PLUS™ to rejuvenate the faded appearance of the surface. Once the desired appearance was achieved the surface was left to cure for 24 hours. After the surface was completely cured, two coats of STAIN-PROOF™ were applied over the surface. By creating a deep dry barrier, STAIN-PROOF™ will continue to protect against future salt efflorescence and staining, whilst ENHANCE-PLUS™ will provide long lasting colour enrichment of the Cantera and Saltillo tiles.

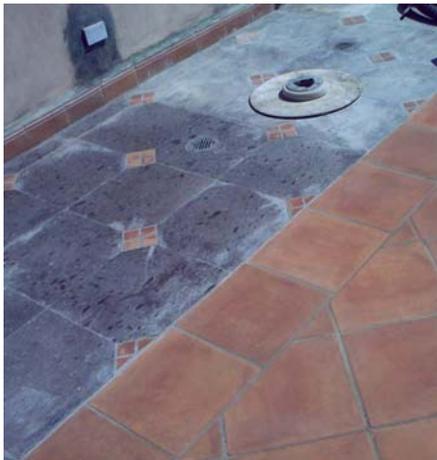
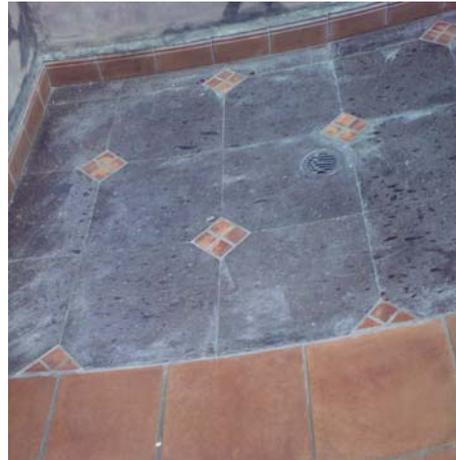
White patches of salt-efflorescence and faded appearance of surface:
